Errata
MSP430F2617 Microcontroller

This document describes the known exceptions to the functional specifications (advisories).

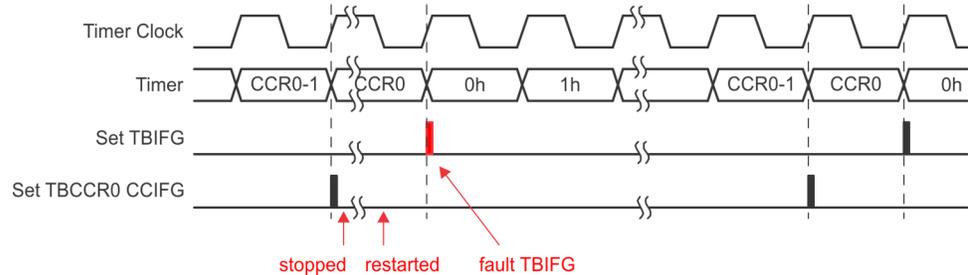
Function TBIFG Flag is erroneously set after Timer B restarts in Up Mode

Description In Up Mode, the TBIFG flag should only be set when the timer resets from TBCCR0 to zero. However, if the Timer B is stopped at TBR = TBCCR0, then cleared (TBR=0) by setting the TBCLR bit, and finally restarted in Up Mode, the next rising edge of the TBCLK will erroneously set the TBIFG flag.

Workaround None.
